Detecting and Eliminating Illicit Discharges in the Stevens Branch Watershed and Stowe

Final Report

February 19, 2016

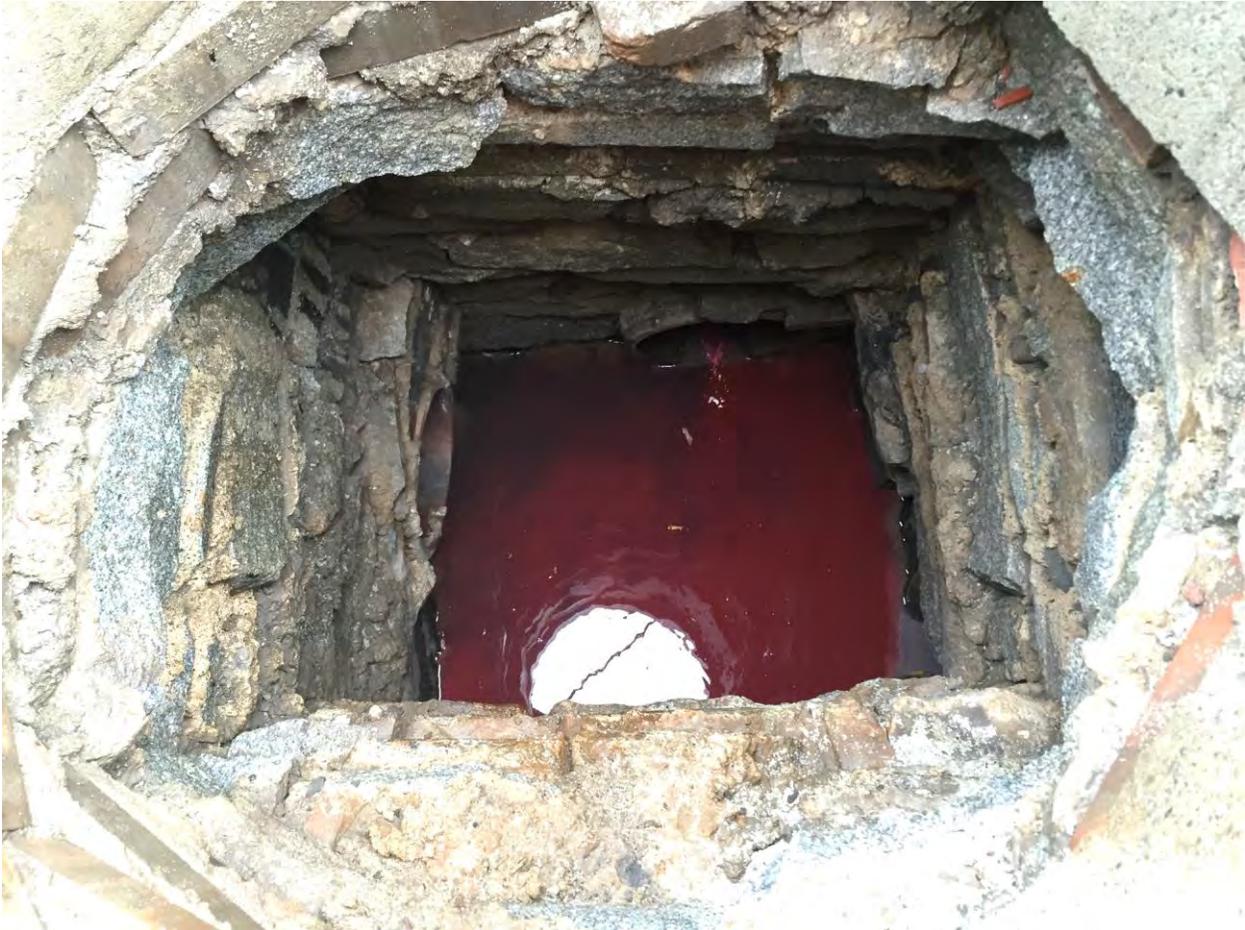
Dye (and wastewater) flowing from a leaking sewer main into a catchbasin on Hill Street in Barre, November 24, 2015. Two leaking sections of the sewer main were replaced in December, 2015.

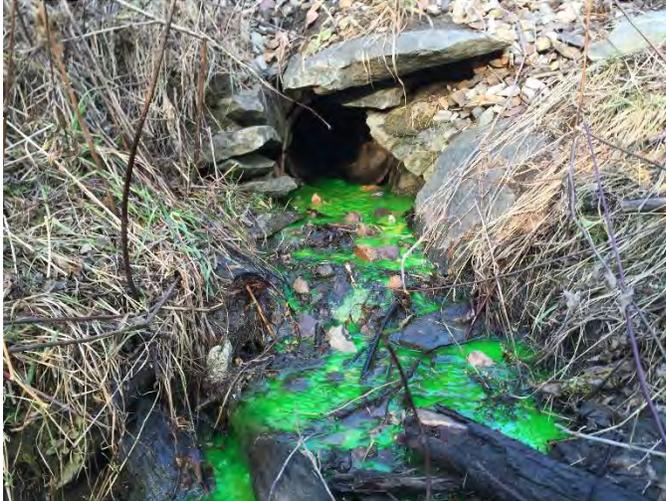
Figure 6. Dye poured into the sanitary sewer overflow pipe is visible at the outfall

Conclusion: Based on wastewater odors and pump sounds repeatedly observed at the outfall, the gray appearance of water in the splash pool below the outfall, and the presence of optical brightener, a direct connection between the sanitary sewer and the stormwater system was suspected. A direct connection via a sewer overflow pipe was confirmed on December 11, 2015.
