**Water Quality Sampling of Mid-Winooski Watershed Streams and Rivers
Summer 2019**

Introduction

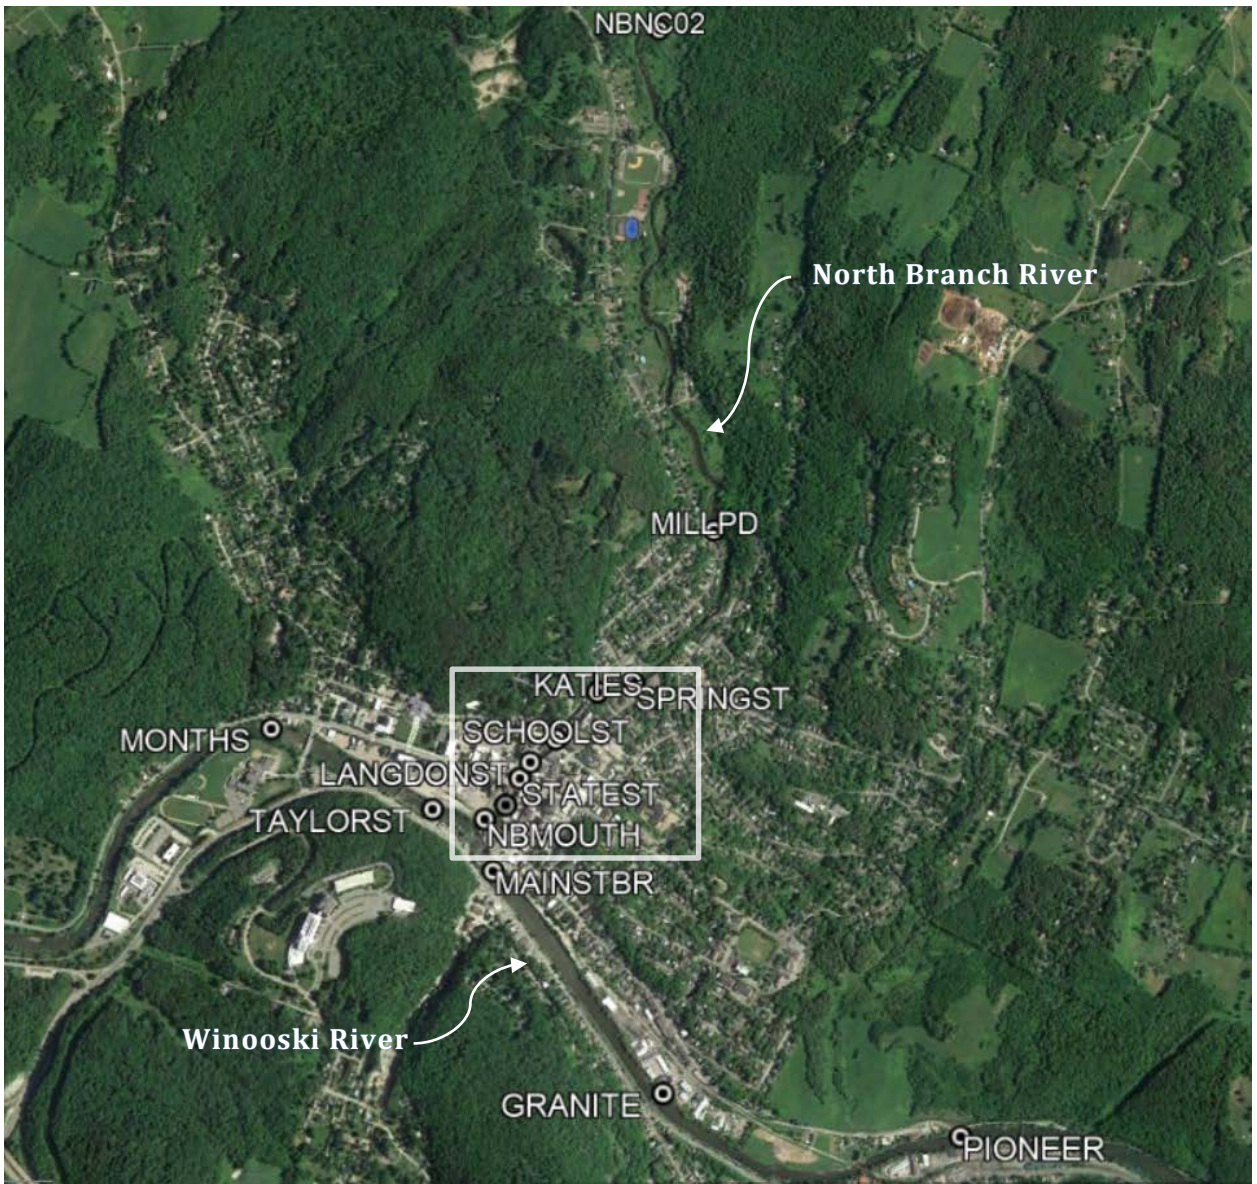
Figure 1. 2019 Four River Partnership sampling locations on the North Branch and Winooski Rivers in Montpelier VT. See following inset in Figure 2 for the locations along the lower North Branch.

In the summer of 2019, Friends of the Winooski River volunteers collected water samples from 24 sites in the mid-Winooski area- five on the Winooski mainstem, nine on the North Branch, two on the Steven’s Branch, four on the Dog, and five on smaller tributaries to test for *E. coli*, phosphorus, turbidity, and/or chloride. Sampling occurred on a total of seven dates: June 25th, July 9th, July 25th, August 6th, August 27st (August 20th for Joiner Brook), September 10th, and September 11th. All dates except September 11th were associated with dry weather with little or no rain in the preceding 48 hours. The site IDs, descriptions, and locations for sites are given in Tables 1-4 and are shown on the maps in Figures 1-4.

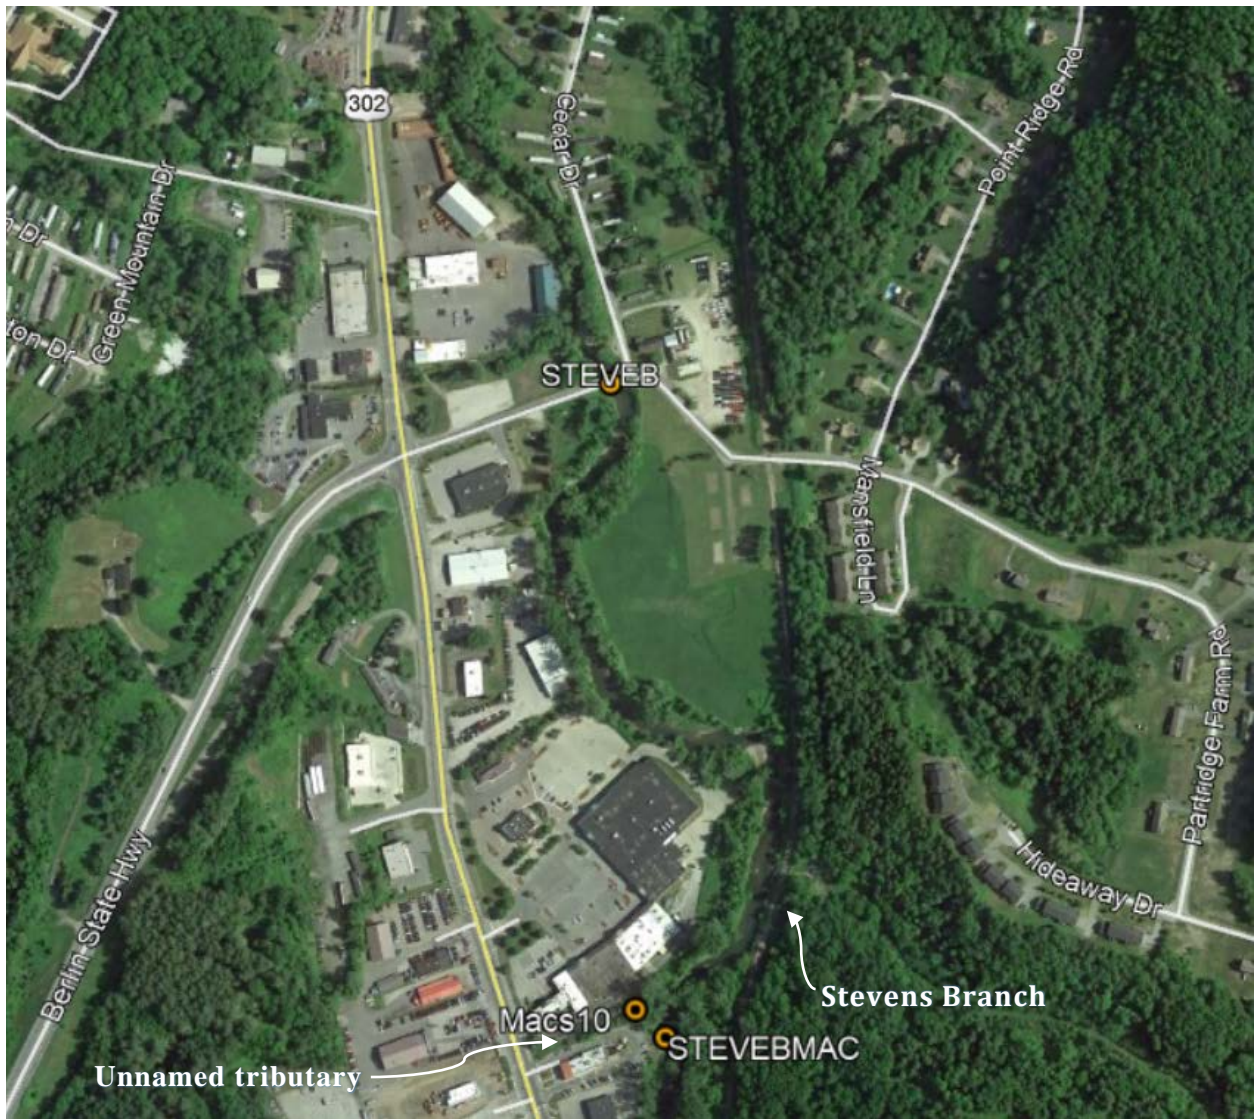
Figure 3. 2019 Four Rivers sampling locations on the Stevens Branch and an unnamed tributary in Berlin, VT

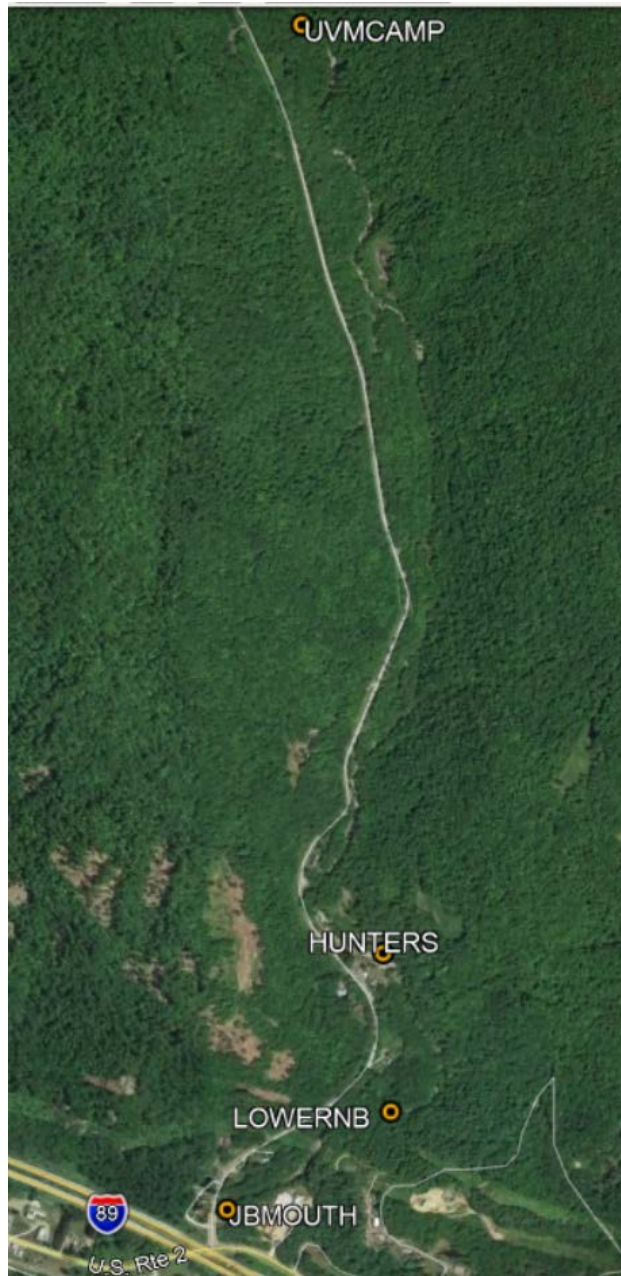
Figure 5. 2019 Four Rivers Partnership sampling locations on Joiner Brook in Bolton, VT

The Friends of the Winooski River expanded our 2019 sampling to include several sites in the Dog River watershed in Northfield and Joiner Brook in Bolton after being contacted by Northfield community members interested in learning more about the water quality of their local streams and the Vermont River Conservancy, which was interested in learning more about suspected water quality problems affecting the Bolton Potholes, which it had acquired in 2018. *E. coli* sampling at three sites in Northfield were added – two on the Dog River and one on Cox Brook (Figure 4 and Table 2), and four on Joiner Brook – three above Bolton Potholes, and one at the mouth of Joiner Brook (Figure 5).

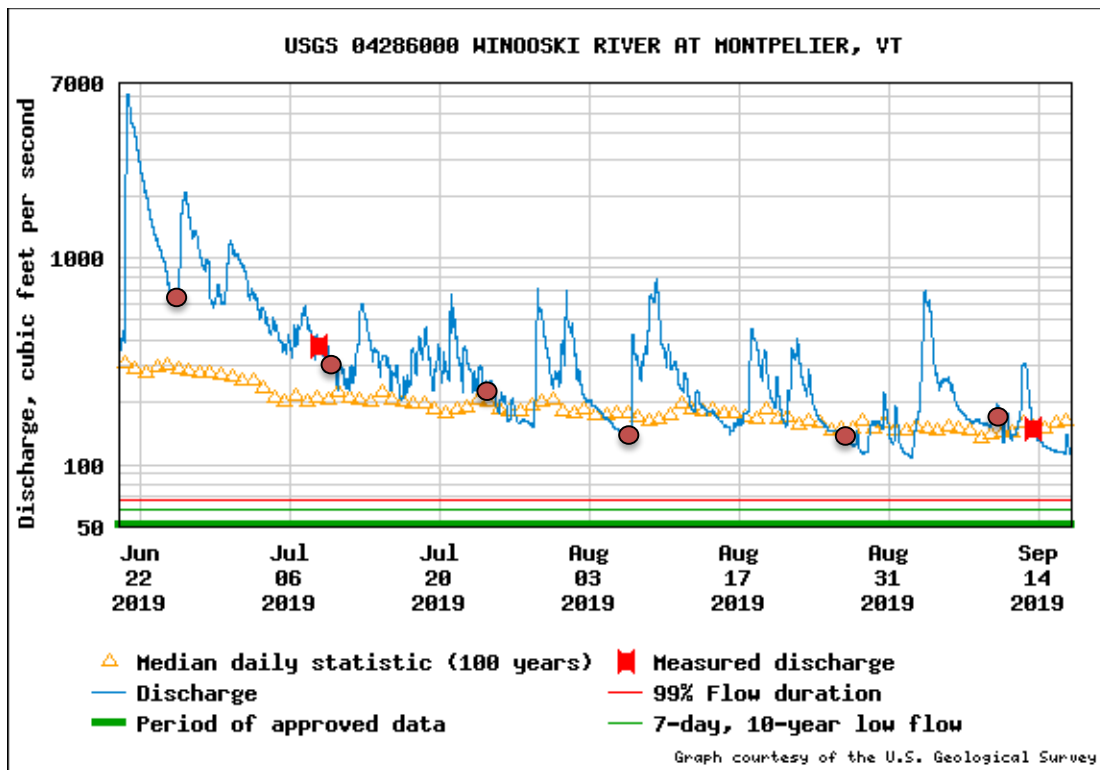
Figure 6. Discharge at the Winooski River gauge at Montpelier, VT during the summer of 2019. The discharge on the regular sampling dates and the rain event dates is indicated by the red circles.

The daily discharge measured on each sampling date at the USGS stream gauges on the Winooski River downstream of Montpelier (USGS gauge 0428600) is shown in Table 7. Comparing these values to historical observations can help determine relative flow levels occurring on the sampling dates. For example, the flow level on 6/25 (1020 cuft/sec) was above the 75th quartile (693 cuft/sec), and so would be considered high. Flow levels on both July sampling dates were between the 25th and 75th quartile, and would be considered medium, and the August and September flow levels would be considered low since they fell below the 25th quartile. Figure 6 shows a hydrograph of the discharge on the Winooski River downstream of Montpelier for the summer 2019 season, with the flow levels on the day of sampling indicated.

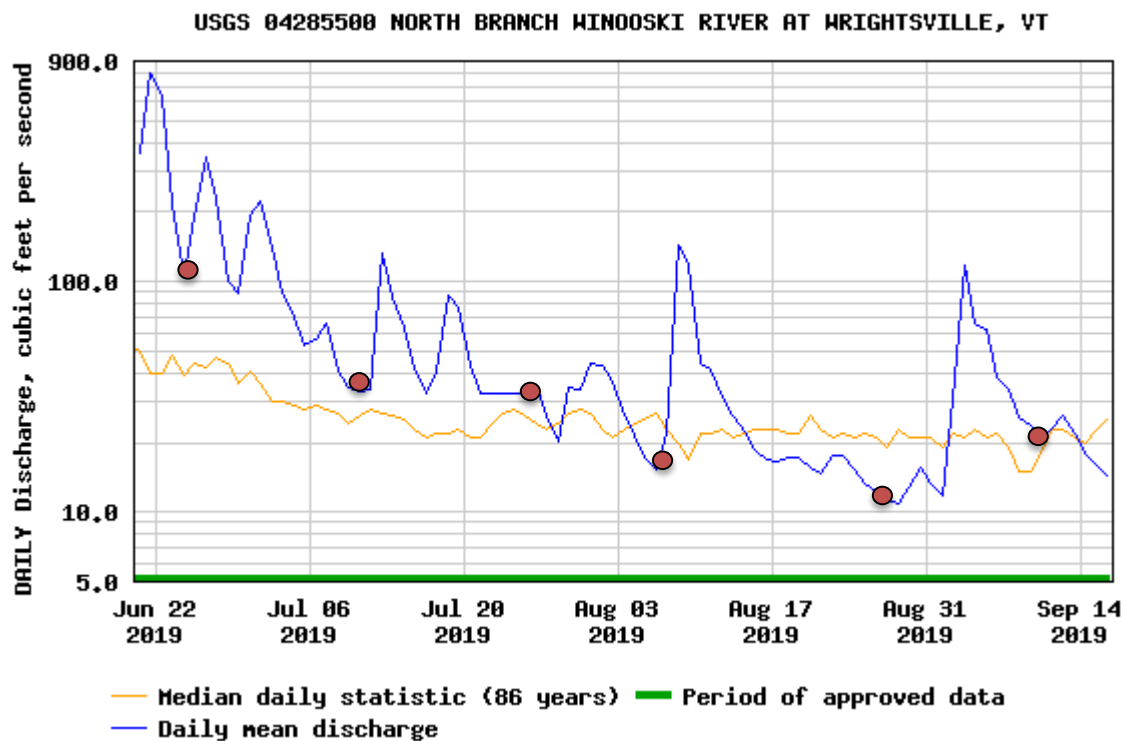
Figure 7. Discharge at the North Branch River gauge at Wrightsville Dam, VT during the summer of 2019. The discharge on the sampling dates is indicated by the red dots.

The discharge measured at the USGS stream gauges on the North Branch River downstream of the Wrightsville dam and upstream of the sampling site NCNB02 (US04285500) on the 2019 sampling dates relative to the Q25 and Q75 quartiles are shown in Table 8. Based on the VT DEC's Guidance on stream flows, the flow level on June 25 would be considered high, the levels on the July dates would be considered medium, and the levels on the August and September sampling dates would be considered low. Figure 7 shows a hydrograph of the discharge on the North Branch for the summer 2019 season, with the flow levels on the day of sampling indicated.

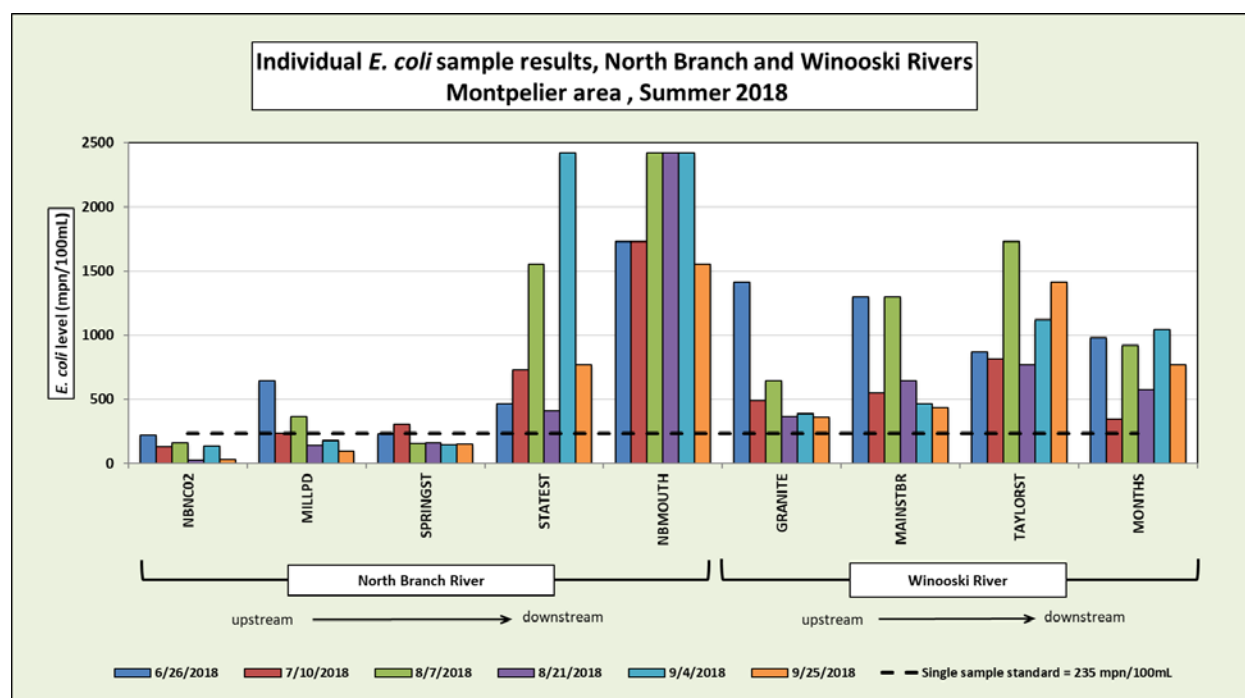
Figure 8. Individual *E. coli* sample results for 6 dry-weather 2018 sampling dates in the Montpelier area at five sampling locations on the North Branch River and four locations on the Winooski. The EPA standard for individual samples (235 mpn/100mL) is shown by the dotted line.

E. coli levels in the Winooski River in Montpelier have been high for many years. The river has consequently been listed as impaired by the State of Vermont for the reach from Pioneer Street Bridge to its confluence with the Dog River. Beginning in 2015, the Friends of the Winooski River has attempted to track down *E. coli* sources in the city. In 2017, a concerted sampling regime on the Winooski mainstem revealed an uptick of the bacteria between Main Street and Taylor Street bridges, near the confluence of the North Branch with the Winooski. To determine whether the North Branch might be contributing *E. coli* to the Winooski, we sampled the mouth of the North Branch River (just below the railroad bridge and the “rat dam”) in 2018. *E. coli* levels at this new NBMOUTH site were extremely high on all 6 dates sampled compared to upstream sites (Figure 8).

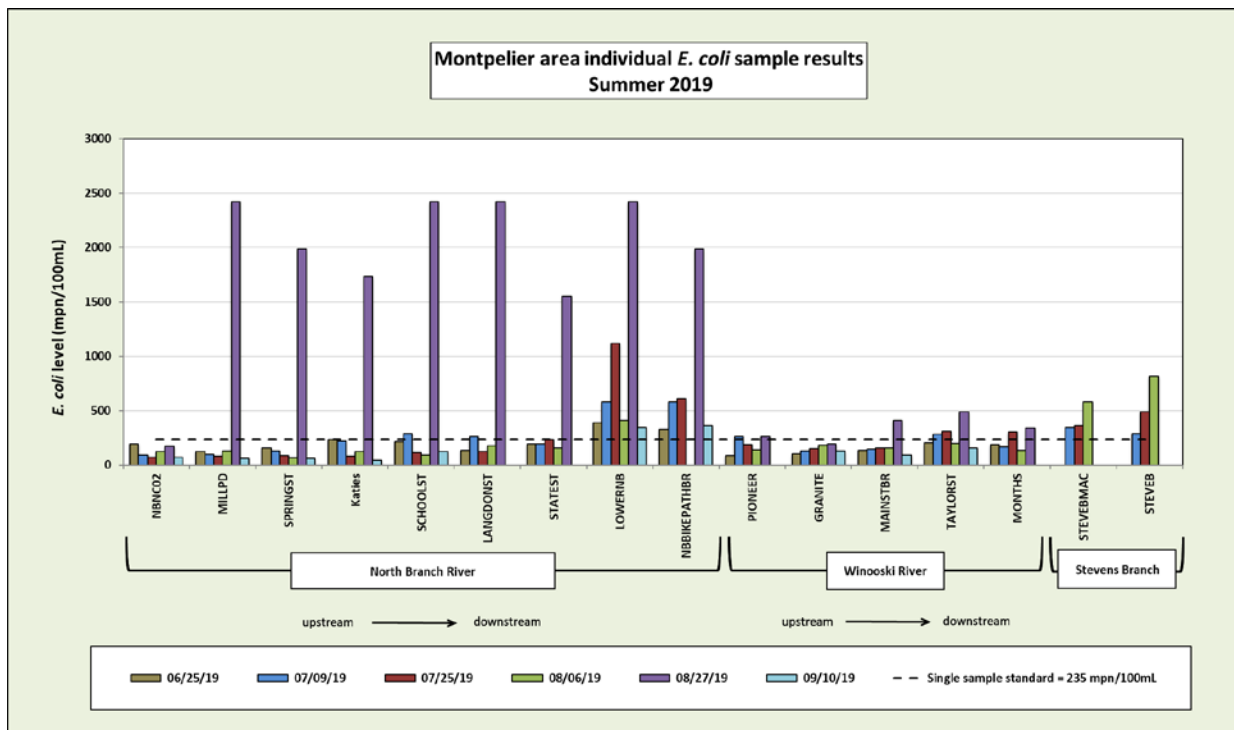
Figure 9. Individual *E. coli* sample results for 16 sampling locations on the North Branch, Winooski Stevens Branch Rivers in the Barre-Montpelier area. The EPA standard for individual samples (235 mpn/100mL) is shown by the dotted line.

The individual sample results of the Montpelier-area *E. coli* monitoring are shown in Figure 9. *E. coli* levels at all sites in all three rivers sampled were almost uniformly lower in 2019 than in 2018. This may be due at least in part to the fact that 2018 was a somewhat drier year than 2019, with river flow providing less of a diluting effect on illicit discharges. Base flow discharge in the Winooski River during June and July of 2018 were approximately 100-150 cuft/sec, for example, whereas the discharge during the same period of 2019 were 250 to 600 cuft/sec.

Most samples had *E. coli* levels below the single-sample maximum of 235 mpn/ml except for the two downstream-most sites on the North Branch and the two sites on the Steven's Branch, where all the samples taken exceeded the single-sample maximum. On one date, 8/27/2019, all North Branch sites except the most upstream site had extremely high *E. coli* readings. On August 28, Friends of the Winooski River staff observed what appeared to be a leaky sewer manhole cover discharging onto Cummings Street near its bridge over the North Branch. This was reported to the Montpelier Department of Public Works, who fixed the issue. The subsequent samples taken from the North Branch on had levels similar to the first four sampling dates. Individual samples from the extreme lower North Branch at LOWERNB and NBBIKEPATH contained higher concentrations of *E. coli* than those from upstream sites by a factor of 2 or more. 2019 levels at these lower North Branch River sites were not as high as 2018 levels at the North Branch mouth, however, when all samples taken during the sampling season had *E. coli* concentrations over 1500 mpn/100mL.

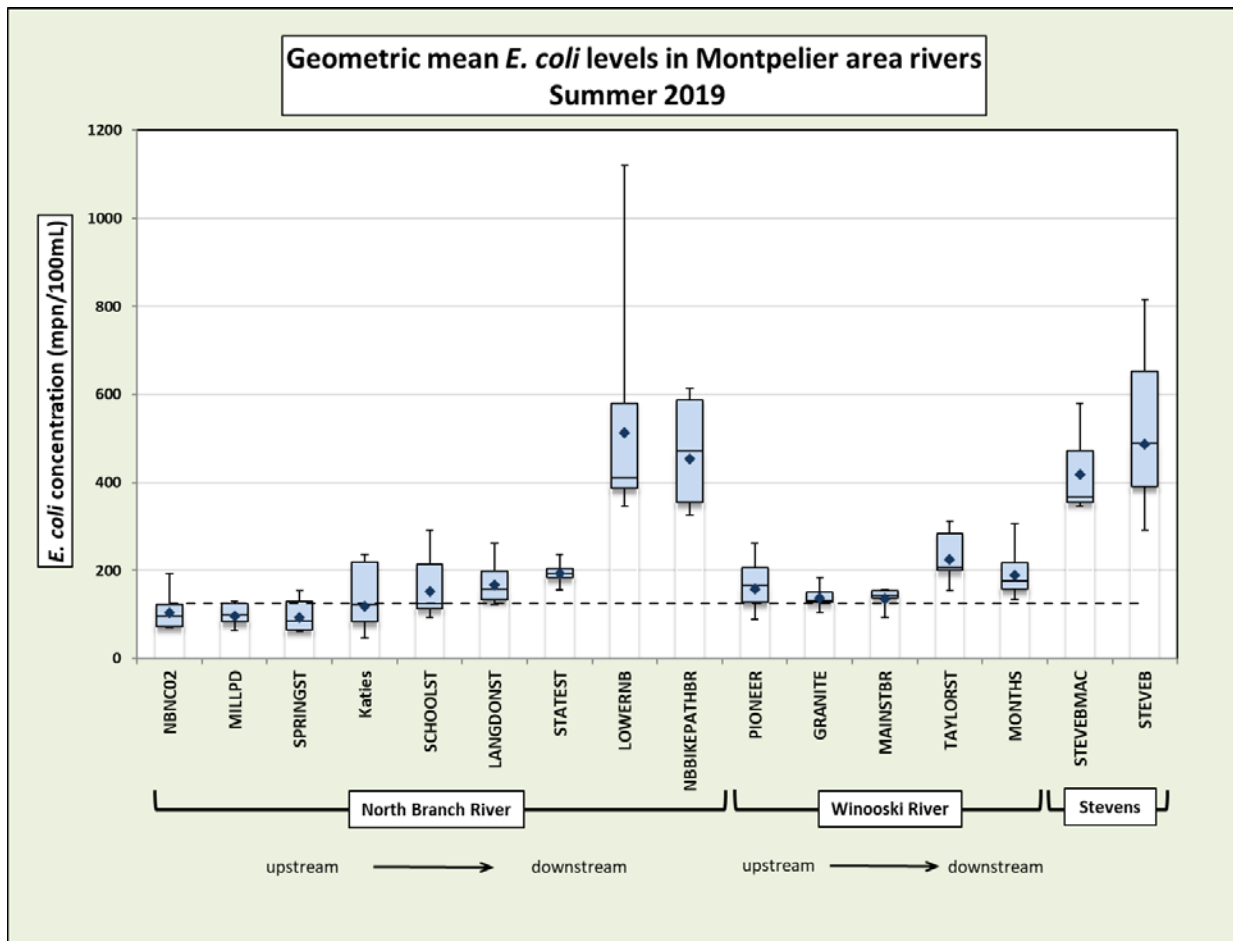
Figure 10. Box and whisker plot of 2019 *E. coli* concentrations at sampling locations on the North Branch and Winooski Rivers. The geometric mean values for each site are shown by the blue diamonds, and the geometric mean standard of 126 mpn/100mL by the dashed line. First and third quartiles are shown by the light blue boxes, separated by the median value. Minimum and maximum values are shown by the whiskers. 8/27 sampling results were eliminated from the analysis since high *E. coli* levels on that date seemed to be due to an isolated incidence of a sewer line leak that was repaired soon after sampling.

A summary of the *E. coli* results for each site relative to the geometric mean standard (126 mpn/100mL) is shown as a box plot in Figure 10. The 8/27 results were eliminated from most North Branch sites for this graph since the high *E. coli* readings that day seemed to be due to an isolated sewer leak incident that was soon eliminated. On the North Branch, geometric mean *E. coli* values met the Vermont water quality standard from the North Branch Nature Center (NBNC02) downstream to 127 Elm Street (Katies). Levels at the School Street Bridge (SCHOOLST), Langdon Street Bridge (LANGDON) and State Street Bridge (STATEST) exceeded the standard somewhat and inched up from upstream to downstream.

A significant jump in geometric mean *E. coli* levels appears on the North Branch between the STATEST (192.8 mpn/100mL) and the two downstream sites LOWERNB and NBBIKEPATH (513.2 and 453.4 mpn/100mL, respectively). While these values were much lower than those recorded at the nearby NBMOUTH site in 2018, when the geometric mean value for *E. coli* at the NBMOUTH site was 2010 mpn/100mL, the data suggests that there is a source of *E. coli* to the lower North Branch is located downstream of the State Street bridge. Note, however, that since the NBBIKEPATH site sampled in 2019 in place of the NBMOUTH site where extremely high *E. coli* levels were observed in 2018, it is possible an additional source is present between NBBIKEPATH and NBMOUTH (see Figure 2).

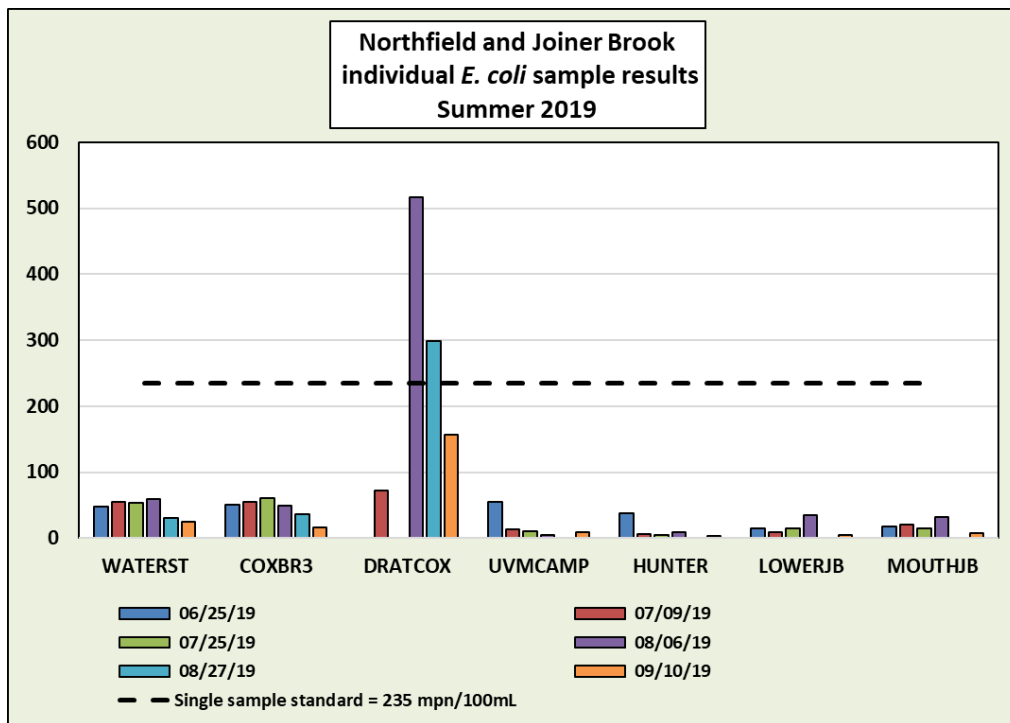
Figure 11. Individual *E. coli* sample results for sampling locations in Northfield and on Joiner Brook in Bolton. The EPA standard for individual samples (235 mpn/100mL) is shown by the dotted line.

The *E. coli* levels in each individual sample taken in Northfield and from Joiner Brook is shown in Figure 11. All samples at all sites had *E. coli* levels well below the single-sample maximum standard except for those collected at DRATCOX, a swimming hole on the Dog River at the confluence of Cox Brook. Two out of four samples taken at this site had levels that exceeded the standard. Likewise, the geometric mean *E. coli* levels (Figure 12) at all sites except DRATCOX met the geometric mean *E. coli* standard, while levels at DRATCOX did not. It appears, therefore, that a fecal matter source exists somewhere between the DRATCOX and the WATERST site further upstream on the Dog River.

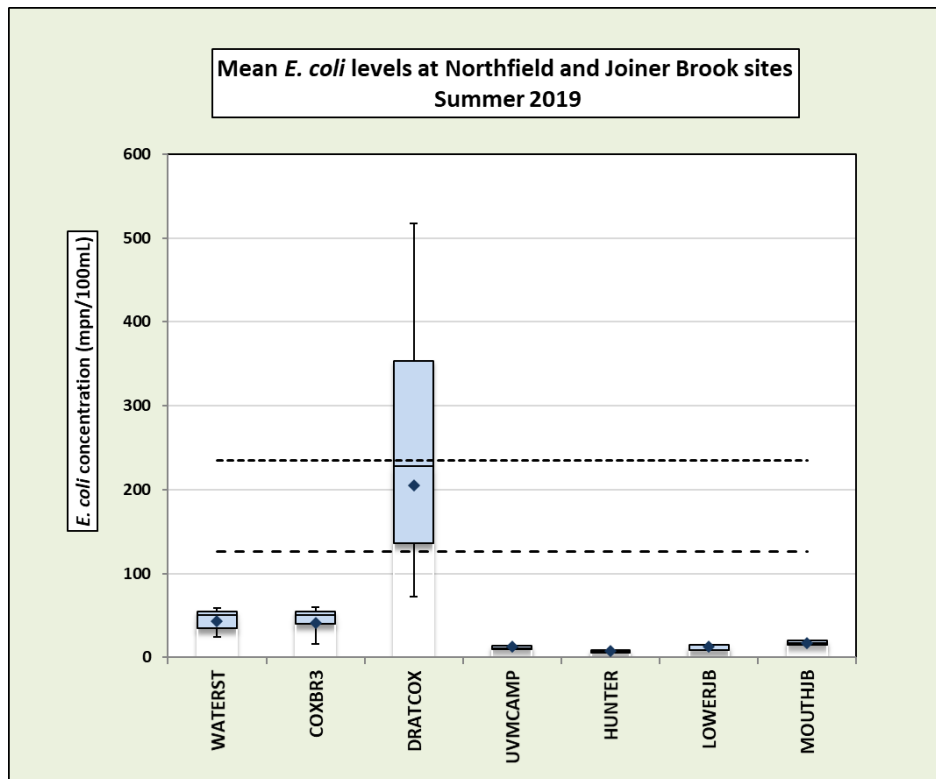
Figure 12. Box and whisker plot of 2019 *E. coli* concentrations at sampling locations on the North Branch and Winooski Rivers. The geometric mean values for each site are shown by the blue diamonds, and the geometric mean standard of 126 mpn/100mL by the dashed line. First and third quartiles are shown by the light blue boxes, separated by the median value. Minimum and maximum values are shown by the whiskers. 8/27 sampling results were eliminated from the analysis since high *E. coli* levels on that date seemed to be due to an isolated incidence of a sewer line leak that was repaired soon after sampling.

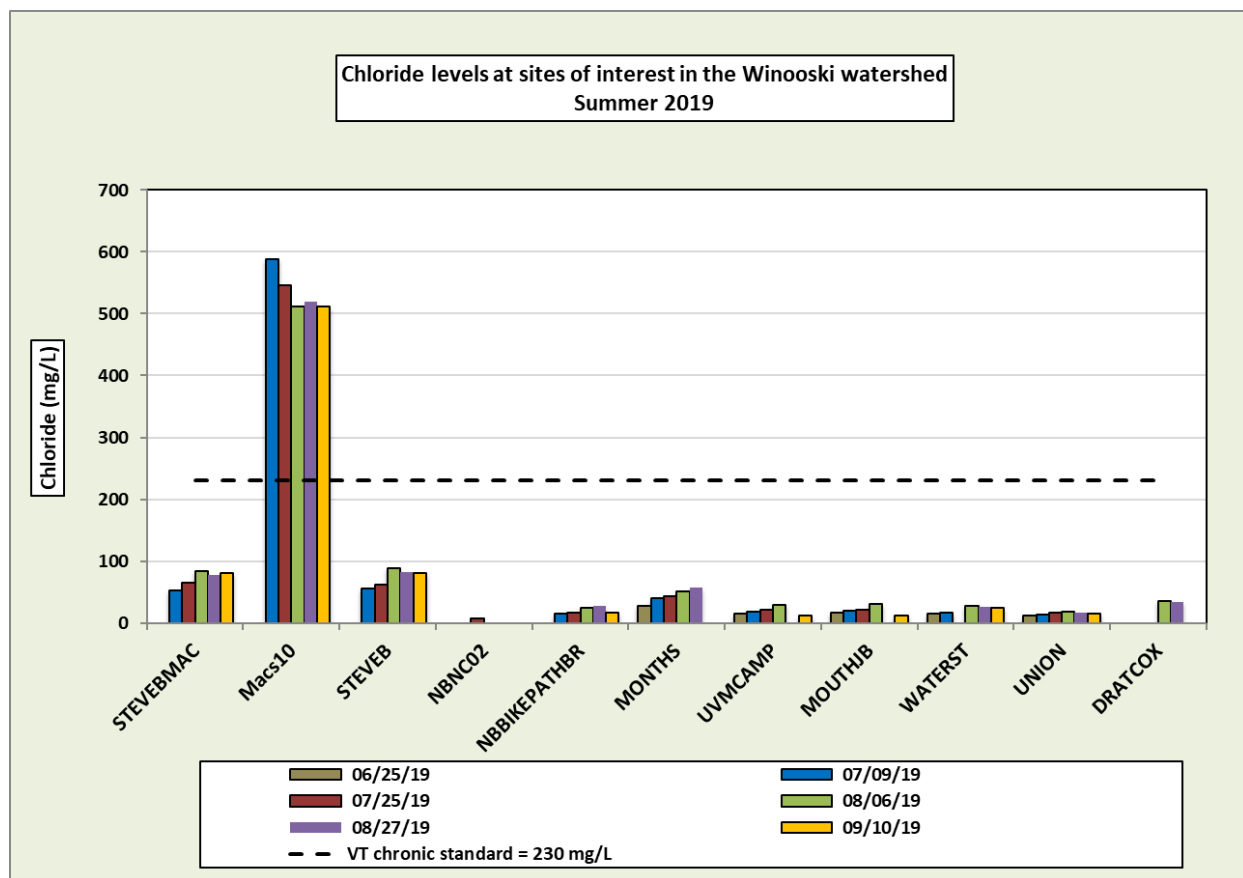
Figure 13. Chloride levels at 11 sites in the Winooski River watershed during the summer of 2019.

The Friends of the Winooski River sampled for chloride at ten sites in 2019, three in Berlin in the Stevens Branch subwatershed, two on the North Branch River, one on the Winooski River downstream from Montpelier, two on Joiner Brook, and three in the Northfield area. Chloride levels were fairly low at all sites except at Macs10, a site at the mouth of a tributary to the Stevens Branch (Figure 13). The two sites on the Stevens Branch mainstem also had elevated chloride levels, but were lower than the 230mg/L standard. Levels on the Winooski River at MONTHS were also slightly elevated.

As in previous years, chloride levels at Macs 10 were consistently very high. Prior stormwater outfall monitoring and stream sampling further up in this stream's watershed strongly suggests that road salt use on the parking lots of the Central Vermont Medical Center has contaminated the groundwater feeding this stream. The Friends of the Winooski River have been in communication with the facilities manager at the medical center to help the facility get information on updated de-icing techniques and will continue to monitor this site. The Friends have not heard from CVMC whether any changes have been made regarding salt use on parking lots, despite requests for that information.

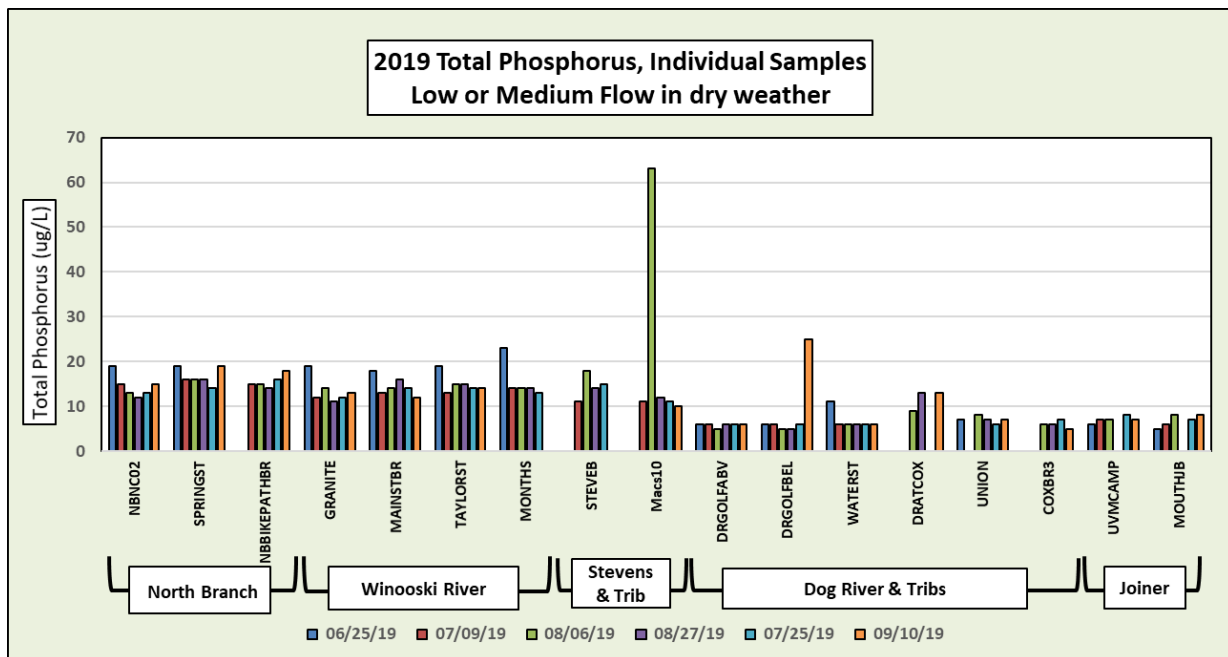
Figure 14. Total phosphorus levels for individual samples collected during low to medium flow in Montpelier, Berlin, Northfield, and Bolton in 2019.

Total phosphorus levels in individual samples at these sites were generally under 20 ug/mL except for occasional higher readings. The phosphorus concentration at the North Branch, Winooski River, and Stevens Branch sites were higher overall than at sites on the Dog River, Cox Brook, Union Brook, and Joiner Brook. Two samples, one from a site (Macs10) on the unnamed tributary to the Stevens Branch, and one taken from the Dog River below the Northfield Country Club golf course (DRGOLFBEL), had relatively high readings. Since these samples were taken during a period of dry weather, stormwater run-off could not have been a factor. These higher readings must therefore have been due to some other event such as recent application of fertilizer upstream. Note there is no standard in Vermont for phosphorus concentrations in single samples.

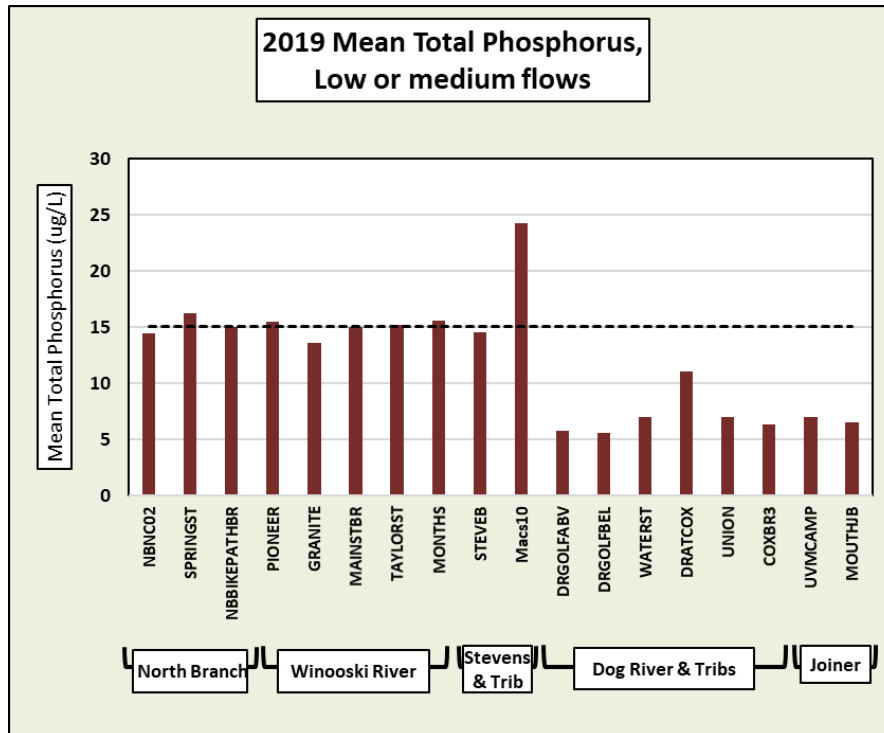
Figure 15. Mean total phosphorus at sampling sites in Montpelier, Berlin, Northfield, and Bolton in 2019. The dotted line shows the VT mean total phosphorus criteria for aquatic biota for Class B, medium high-gradient streams.

Figure 15 shows the mean total phosphorus for the 2019 June-September season for low to medium flows. The mean total phosphorus criteria for aquatic biota in Vermont is based on the stream type. Class B, medium-sized high-gradient streams have a standard of 15 ug/L, while larger, slower Class B streams have a standard of 27 ug/L. The dotted line in the Figure 15 corresponds to the 15 ug/L criterion. Another way of thinking about phosphorus concentrations is to ask whether a particular waterway contributes phosphorus to Lake Champlain or has a diluting effect. Since the target goal for phosphorus levels in the Main Lake of Lake Champlain is 10 ug/L, the North Branch, Winooski (in the Montpelier area), and Steven's Branch Rivers – which all have mean total phosphorus concentrations above 10 ug/L - area would be expected to be contributing to the phosphorus in the lake, while the Dog (in Northfield), its tributaries, and Joiner Brook would be expected to have a diluting affect.
